Re: Waste issues at Haulbowline Island, County Cork

Background

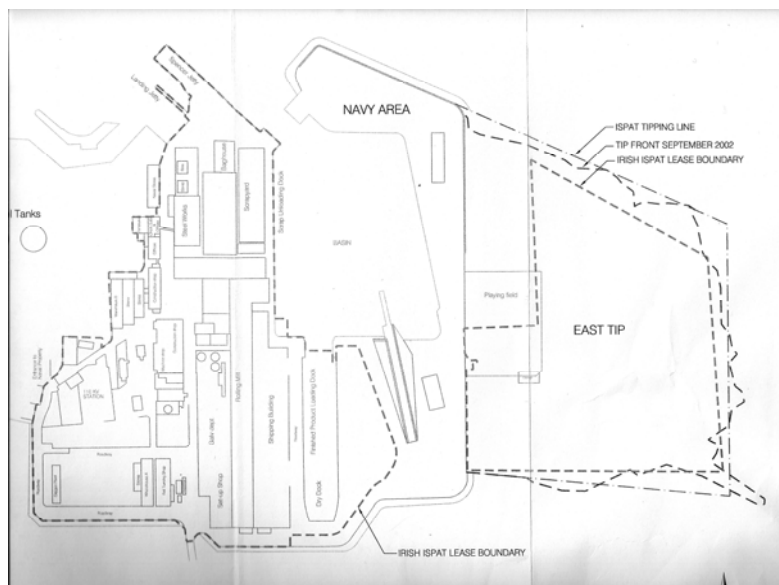
The area covered by the Licence to ISPAT is shown in Figure 1 below. The East Tip is 9 hectares in extent and the Steel Site, East Camber, and South Tip comprise a further 11.3 hectares.

Figure 1: Total areas of IPCC Licence 20.3 hectares²
